IN-DEPTH INSPECTION REPORT

P.I.N. X051.59

B.I.N. 1076610

TEAM LEADER IAN PETERSEN	<u>106776</u> NYSPE LICENSE #
ASSISTANT TEAM LEADER	SEBASTIAN MERCADO
FEATURE CARRIED Grand Centra	ıl Parkway - Westbound C-D
FEATURE CROSSED Sou	thbound Cross Island Parkway
DATE FIELD WORK BEGAN	1/17/23
DATE FIELD WORK COMPLETED	1/30/23

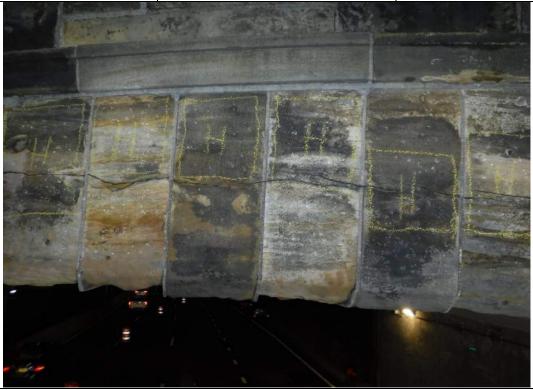
PHOTO: 1 LOCATION: North Fascia at midspan

<u>Fascia</u>: Both the North and South Fascia exhibit minor cracks and deterioration along the arch and ring stones. The North side exhibits small areas where stone pointing is missing up to 3 LF, 12" x 2" of erosion in the 11th ring stone (from the End Abutment), 8 LF by up to 1/4" crack along ring stone 17-23 (from the Begin Abutment) with 1 SF hollow areas on all ring stones around the crack, and up to 50% of the ring stones exhibit erosion up to 2" along the bottom of the arch. The South side exhibits a 5' L x 2" w x 4" deep crack above ring stones 5-8 (from the Begin Abutment), pointing loss in the East side of the South fascia, and up to 50% of the ring stones exhibit erosion up to 3" along the bottom of the arch. (See Photos 1 and 2)

DESCRIPTION: 9 LF crack up to 1" wide and 3/4" deep with 1 SF hollow
Areas on seven (7) ring stones looking South

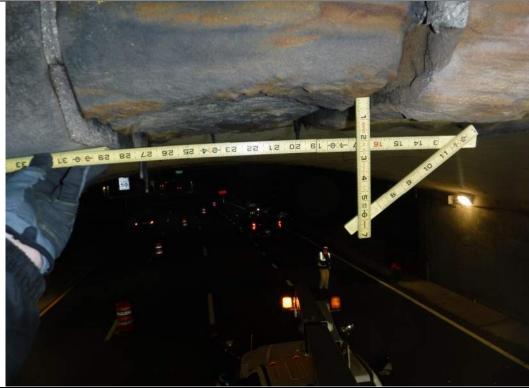
PHOTO: 2

LOCATION: North Fascia at midspan

DESCRIPTION: Deterioration of bottom portion of ring stone up to 2" on

approximately 60% of stones looking South

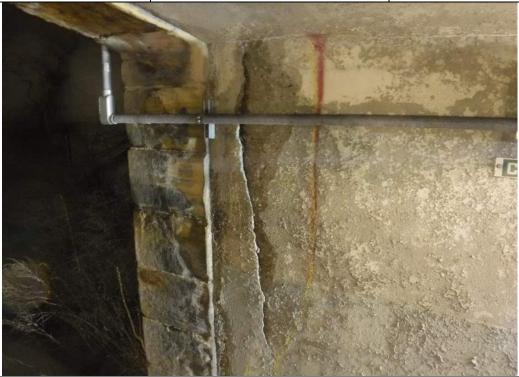
PHOTO: 3

Both abutments are still in fair condition and fully functional. The Begin (West) Abutment exhibits a 25 SF hollow area with an approximately 5 SF spall with no exposed rebar located in the Southwest corner (no loose concrete), multiple hollow areas up to 4 SF in the South side near the roadway, multiple full height cracks up to 1/16", a 9 SF and a 6 SF hollow section in the North side approximately 16 feet from the North fascia, and small hollow section up to 1.5 SF in the North side near the arch. The End (East) abutment exhibits a 9 SF hollow section approximately 15 feet South of North Fascia near roadway, a 8 SF hollow section near South fascia approximately 2 feet above roadway, multiple cracks up to 8 LF and 1/16" in width. (See Photos 3-5)

LOCATION: Begin abutment Southwest Corner

DESCRIPTION: 25 SF hollow area with 5 SF spall with no exposed rebar

Looking Southwest

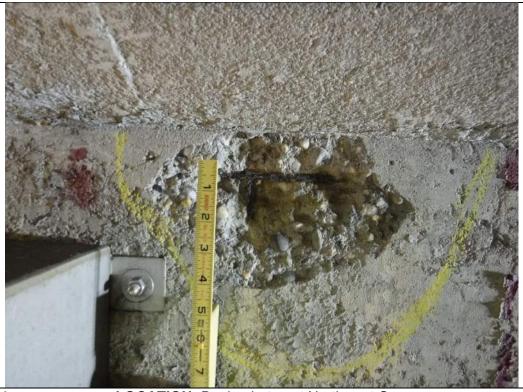
PHOTO: 4

LOCATION: Begin abutment Northwest Corner

DESCRIPTION: 0.5 SF spall with exposed rebar measured at 5/16"

thickness, Looking West

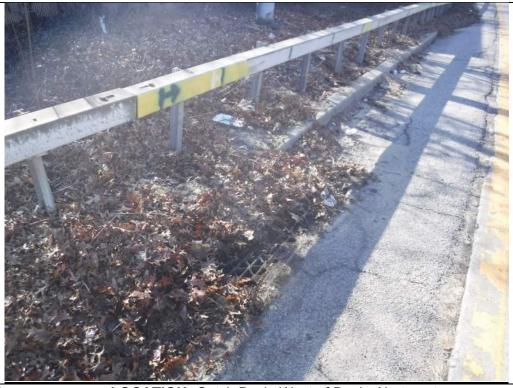
PHOTO: 6

One drainage catch basin exist along the Southside of the Begin approach approximately 65 feet West of Begin joint. Catch basin appears partially clogged with heavy debris in area. (See Photo 6)

LOCATION: Catch Basin West of Begin Abutment

DESCRIPTION: Catch Basin exhibits partial clogging with heavy debris

Looking Southwest

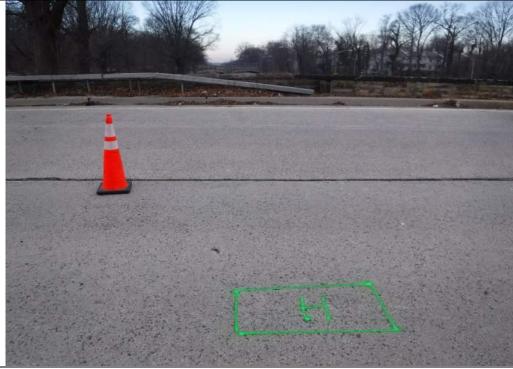
PHOTO: 7

LOCATION: Begin approach 30 feet West of Begin Joint

DESCRIPTION: 4.5 SF hollow area in left lane, no loose concrete

Looking North

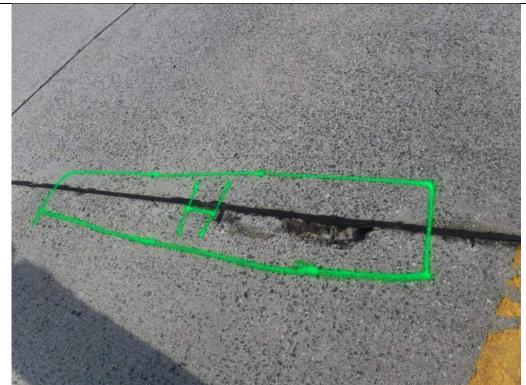
PHOTO: 8 LOCATION: Mid span joint left lane

DESCRIPTION: 10 SF hollow area with 0.5 SF spall along midspan joint Looking Northeast

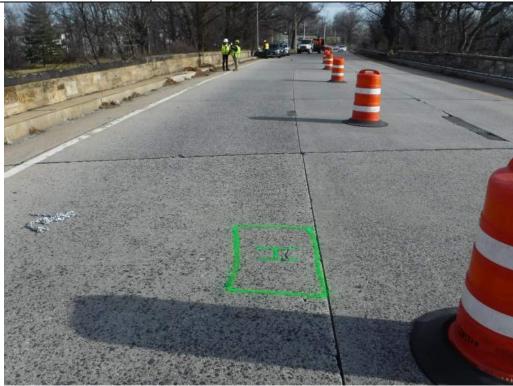
PHOTO: 9

LOCATION: Right lane 9 feet West of End abutment joint
DESCRIPTION: 7 SF hollow area, no loose concrete
Looking East

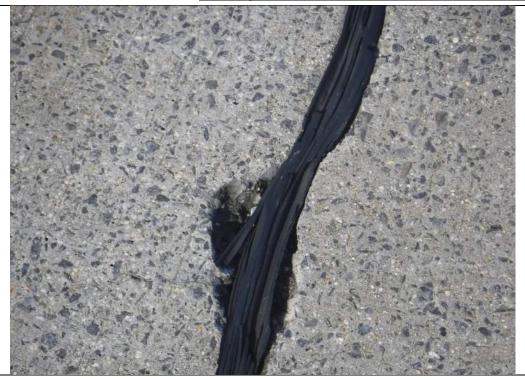
PHOTO: 10

<u>Joints:</u> The sealant on both the Begin (West) and End (East) abutment are beginning to dry out, deteriorate and fray. The cracks that are located on the underside of the center joint may be a result of joint failure allowing water to seep into the arch. (See Photos 10)

LOCATION: Midspan joint near left lane
DESCRIPTION: Joint filler deterioration and fraying allowing water seepage
Looking North

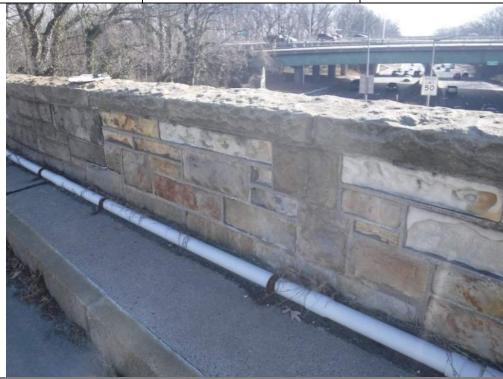
PHOTO: 11

<u>Parapets/Railings:</u> The parapets are in fair condition with multiple areas of stone wearing away and small areas where pointing is missing. All signs of railing post impact have been replaced/ repaired since last

LOCATION: South Parapet interior face at End abutment joint

DESCRIPTION: Multiple locations exhibit loss of stone due to weathering

Up to 3" in 20-30 stones. Looking Southeast

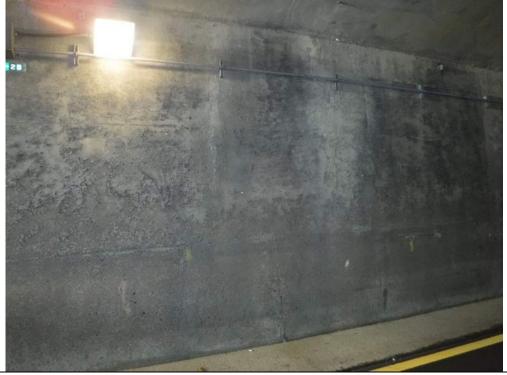
PHOTO: 12

<u>Paint</u>: Paint peeling was noted on the face of the abutments. Paint peeling and paint loss is exhibited over approximately 50% of abutment face. (See Photo 12)

LOCATION: End Abutment

DESCRIPTION: Paint peeling and paint loss exhibited over 50% of face

Looking East

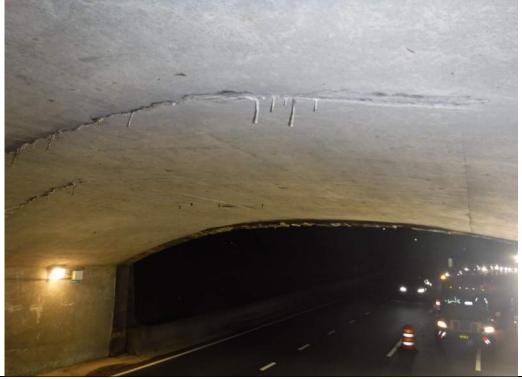
PHOTO: 13

LOCATION: Midspan over Left and Center lane

DESCRIPTION: Multiple cracking with heavy efflorescence exhibited over 9 LF

Looking Northwest

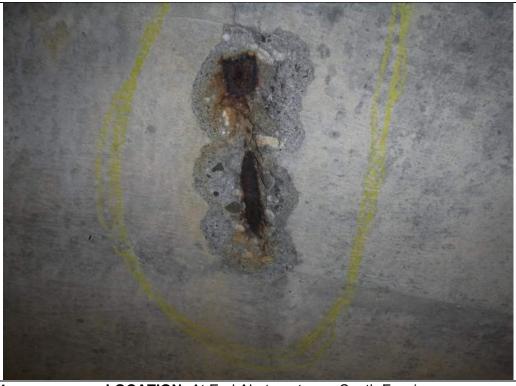
PHOTO: 14

LOCATION: At End Abutment near South Fascia

DESCRIPTION: Underside exhibits 1 SF spall with exposed rebar

Looking East

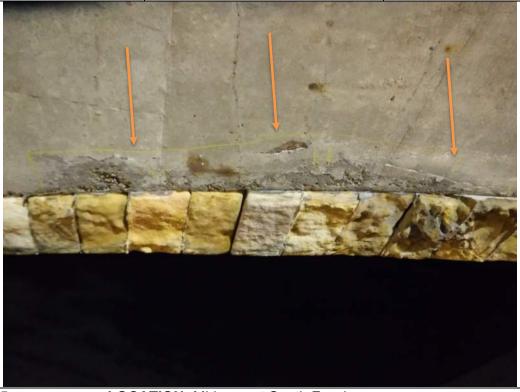
PHOTO: 15

LOCATION: Midspan at South Fascia

DESCRIPTION: Underside of deck exhibits a 8 SF hollow area at ring stone

Looking South

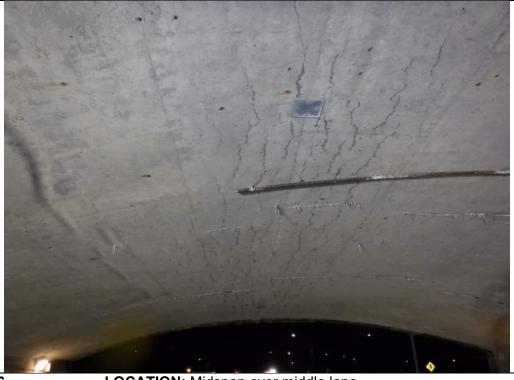
PHOTO: 16

LOCATION: Midspan over middle lane

DESCRIPTION: Underside of deck exhibits multiple cracks across midspan

Looking North

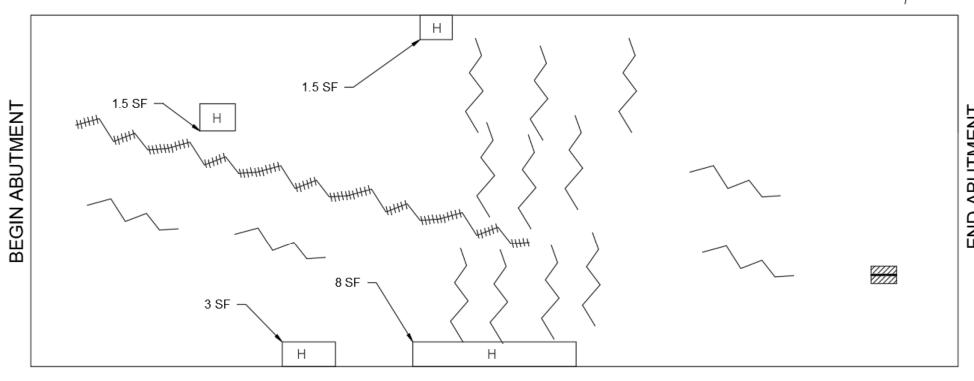
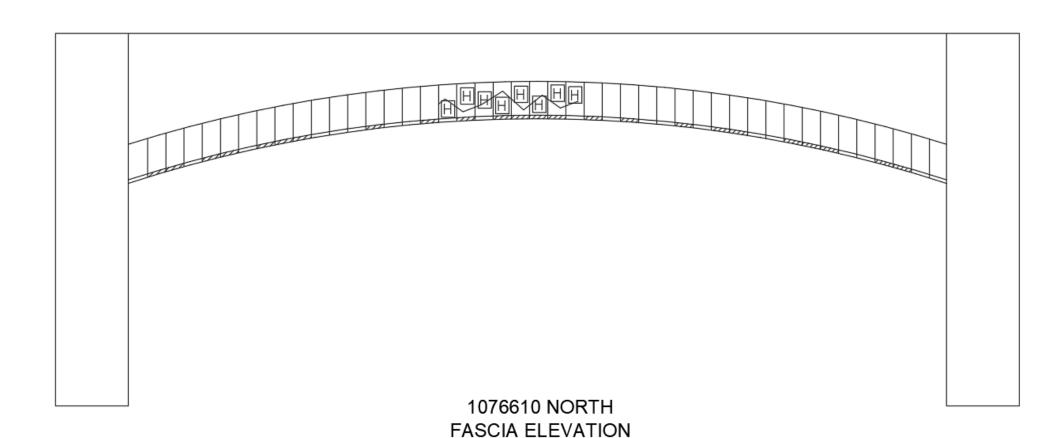
1076610 UNDERSIDE OF ARCH

<u>Underside of Arch</u>: The Underside of the bridge exhibits a 12 LF by 1/16" crack at midspan of bridge with no hollow sound, a 1 SF spall with exposed rebar over the left lane near the South fascia, multiple long cracks up to 14 LF by 1/16" with efflorescence are exhibited over the middle lane, a 1.5 SF hollow area located near midspan over middle lane, a 8 SF and a 3 SF hollow section located on South side against South fascia. (See Photos 13-16)

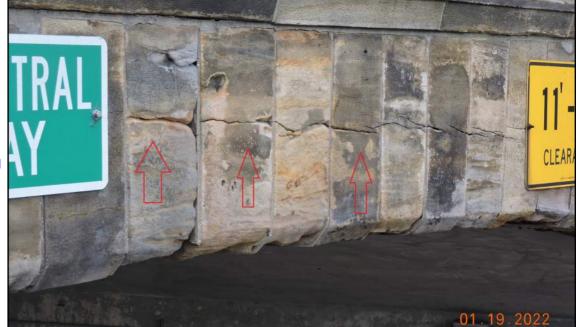
Span 1, the left fascia ringstones exhibit a 15' (L) x up to 1/4" (W) horizontal crack near midspan. The ringstones surrounding this crack sound solid (Photo 2).

Attachment Description: Location: Left Fascia near midspan; Looking Back and Right. Horizontal crack in ringstones. Photo Number: 2

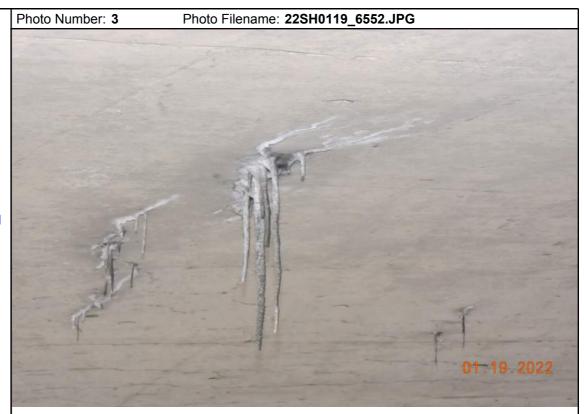
Additionally, the underside of the concrete slab exhibits scattered fine longitudinal cracks with a build-up of efflorescence (Photo 3).

Attachment Description: Location: Underside of Concrete Slab, Right Side; Looking Right. Longitudinal crack with build-up of efflorescence.

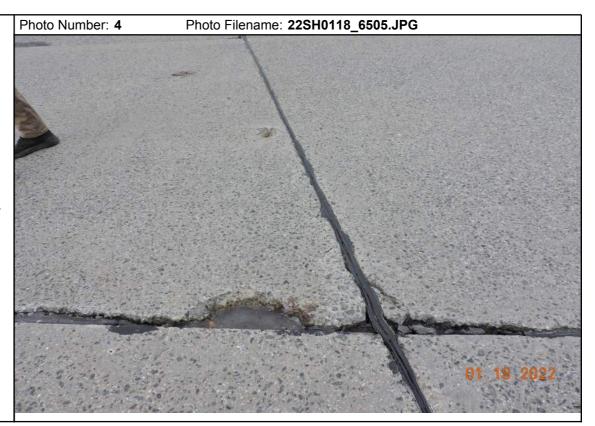
Attachment Description: Location: Span 1, Wearing Surface, Center Lane near Midspan; Looking Down and Left. Spall near construction joint.

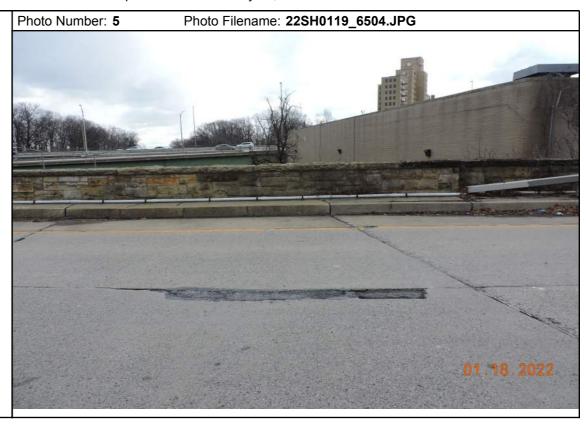
Attachment Description: Location: Span 1, Wearing Surface, Center Lane near Begin Abutment; Looking Down and Left. Uneven asphalt patch.

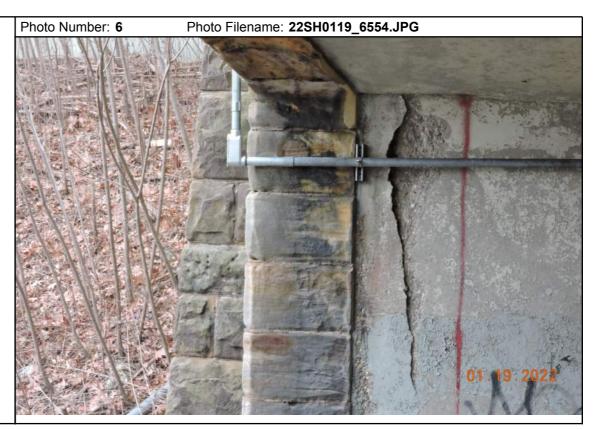
The begin abutment stem has 3 SF x 1.5" deep spall at the right end and a 1/2 SF x 1" deep spall near the left end, both with an exposed rebar. The area surrounding the spall at the right end of the abutment is partially surrounded by hollow sounding concrete which is stable during the inspection.

Attachment Description: Location: Begin Abutment, Right Side; Looking Back. Spall with exposed rebar and hollow sounding concrete.

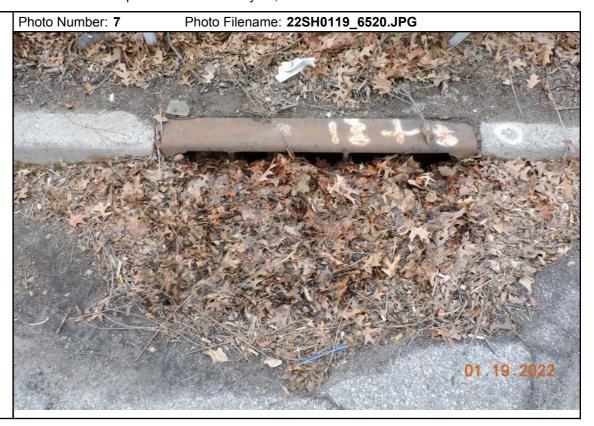
- 6. Vertical Clearance sketch is attached.
- 7. Standard Photos have been updated where appropriate.
- 8. Beyond the Begin Approach, the right catch basin is partially clogged. However, the bridge Begin Approach is sloped away from the bridge and no water ponding was observed at the approach side. There is no safety hazard for this condition at this time. Previously NSCO was issued for this condition. See photo 7.

Attachment Description:
Location: Beyond Begin
Approach, Right catch
basin; Looking Back.
Partially clogged catch
basin.

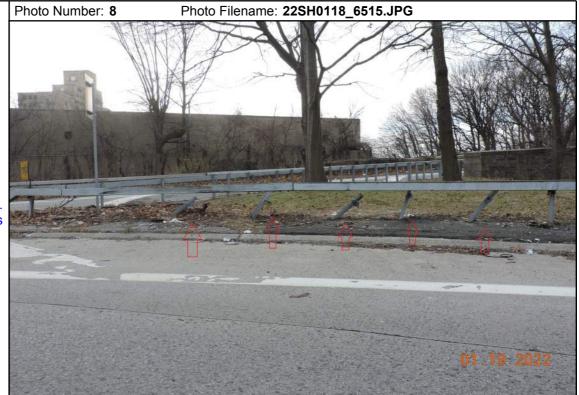
Beyond the Begin Approach, at approximately 60' from the Begin Abutment, the right box beam guide railing exhibits ten consecutive disconnected and bent posts. Also, the horizontal box beam guide railing is deflected down. There is no immediate safety hazard for this condition at this time.

Attachment Description:
Location: Beyond Begin
Approach, Right box beam
guide railing: Looking Right.
Disconnected support posts
and deflected railing. Ref.
NSCO

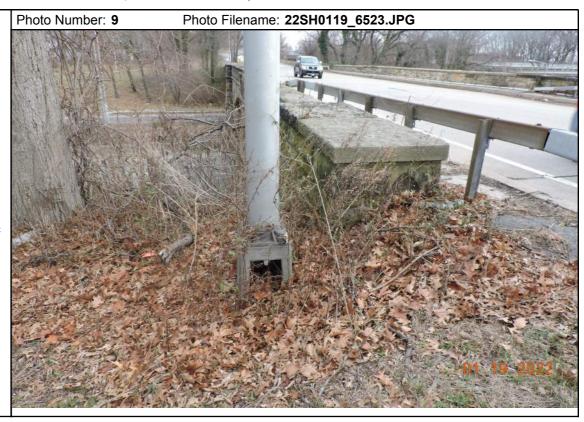
Light post, by the Left of Begin approach, exhibits missing access cover with exposed electric wires (photo 9). This location is in non-pedestrian area and there is no immediate safety hazard for this condition at this time.

Attachment Description:
Location: Light post, by the
Left of Begin approach,
exhibits missing access
cover with exposed electric
wires, Looking ahead. Ref.
NSCO

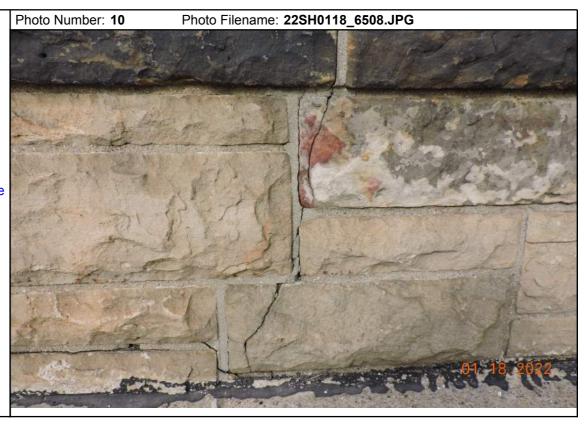
Span 1, the interior face of the Left masonry bridge railing near the Begin exhibits full height vertical crack. Railing was stable during the inspection.

Attachment Description:
Location: Interior face of the
Left masonry bridge railing
near the Begin abutment,
Looking toward Left, full
height vertical crack.
